SALTPETER EFFECTS ON WALLS:

MAIN CAUSES OF SALTPETER IN BUILDINGS

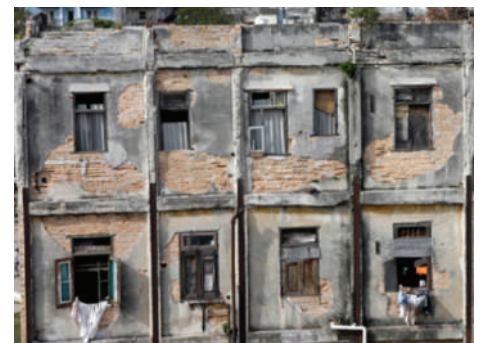
- Presence of water soluble salts (sulphates and chlorides etc.) in building materials.
- Use of porous /under burnt bricks
- Building components exposed to contaminated soil and water.
- Porosity in structural members.
- Inadequate water proofing.

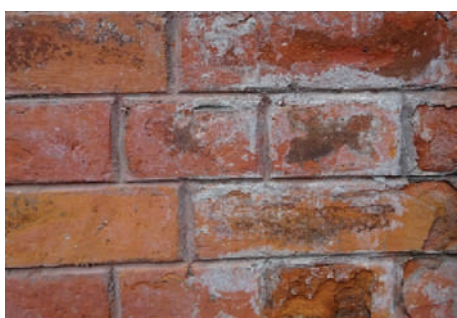
- Ground water/moisture in and around foundations – higher water table.
- Improper roof drainage or faulty/improper water proofing.
- Flaws in parapet walls, coping etc.
- Poor workmanship of water supply and sanitary works – soil pipe sealing and jointing.
- Leaky sunken floors of toilet and kitchens; water makes its way inside sunken floors from joints of tiles.
- Improper construction of chujjas and lintels or slab and walls.
- Improper filling of scaffolding holes.
- Usage of faulty/contaminated materials – porous or under burnt bricks or bricks with high water absorption.

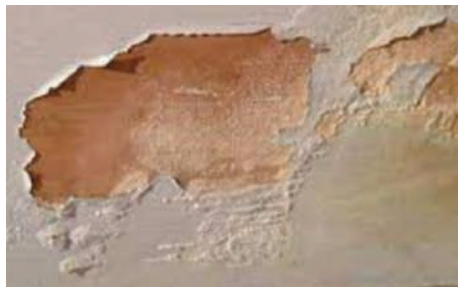
- Faulty drainage system, blockage of drains and pipes, deterioration of pipes due to weathering effect.
- Non approachable ducts – cleaning of these ducts is difficult.
- Damaged/defective construction of septic tank near building structures.
- Construction of soak-pit near building foundations.
- Cracks in the structural elements due to inappropriate design, shrinkage, poor specifications or workmanship.

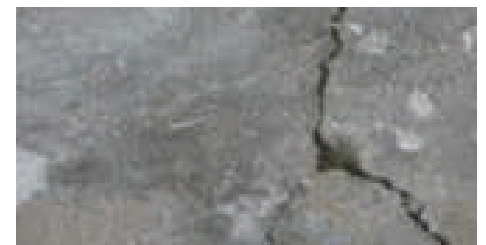
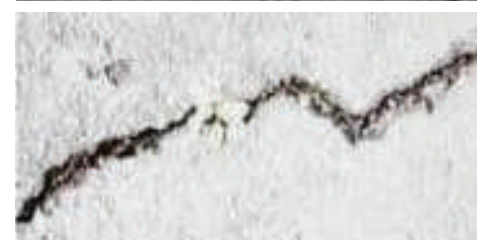
Fig.9: Concrete building cracking due to poor construction practice; water added to fresh concrete.

There is a broad variety of construction practices that lead to concrete cracking. Normally, improper construction practices are due to ignorance, carelessness, greed or negligence. Main causes for poor construction practices:

- Improper selection of materials.
- Selection of poor quality cheap materials.
- Inadequate and improper proportioning of mix constituents of concrete, mortar etc.
- Inadequate control during various steps of concrete production such as batching, mixing, transporting, placing, finishing and curing.
- Construction overloads induced during construction can frequently be more serious than those imposed during service.
- Inadequate quality control and supervision causing large voids (honey combs) and cracks resulting in leakages and ultimately causing faster deterioration of concrete.
- Improper construction joints between subsequent concrete pours or between concrete framework and masonry.

- Addition of excess water in concrete and mortar mixes.
- Lastly, poor quality of plumbing and sanitation materials and practices.

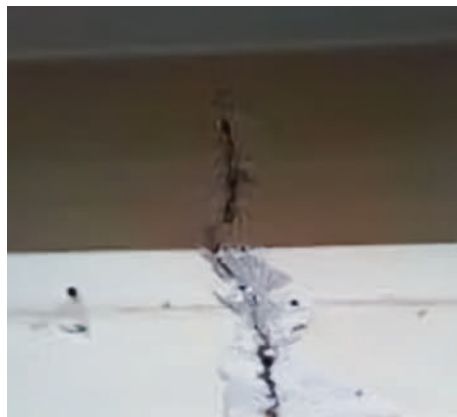
Fig.10: Major structural crack in beam due to poor detailing practice.

Several problems can occur due to incorrect structural design, detailing, and specifications.

Errors that may occur at this stage include inadequate thickness, insufficient reinforcement, incorrect geometry, improper utilization of materials and incorrect detailing.

Problems encountered due to those errors include cracking due to insufficient reinforcement, excessive differential movement due to improper foundation design, increased concentration of stresses as a result of poorly designed re-entrant etc.
